Report of Findings

The Carallton Isles Condominiums
Milestone Structural Assessment

Prepared For:
The Carallton Isles Condominium
419 Golden Isles Drive
Hallandale Beach, FL 33009

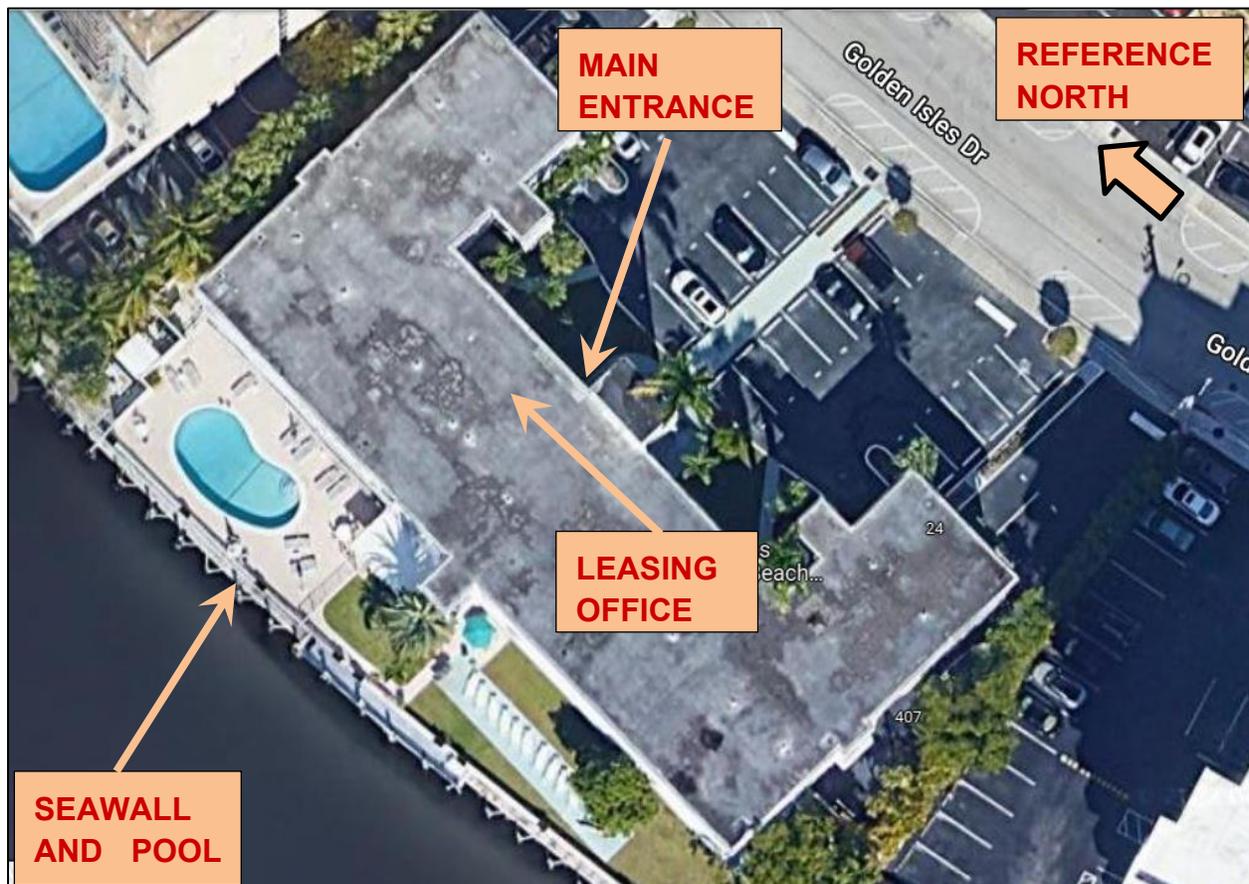
Figure 1 – An aerial view of The Carrallton Isles Condominium property. The aerial view was taken by Google. Notations by Rimkus.

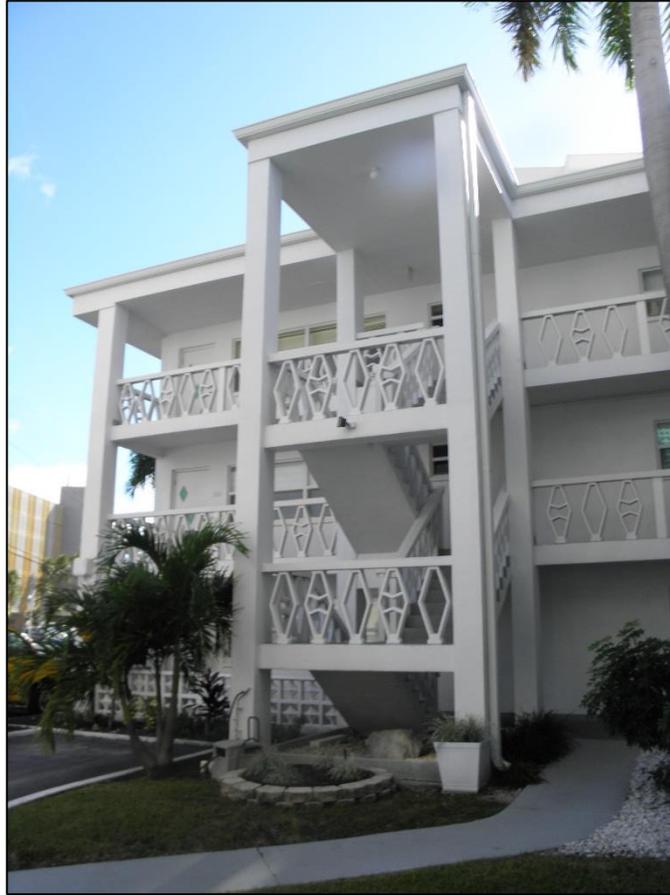
Photograph 5

Typical view of stair tower at north and south wings.

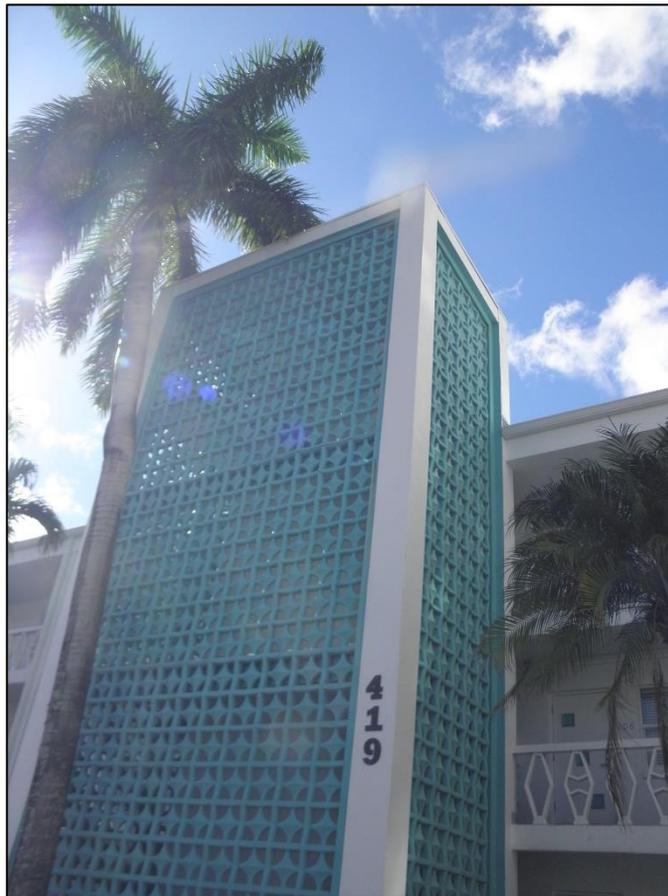
Photograph 6

View of central stair/elevator tower on east side of building.

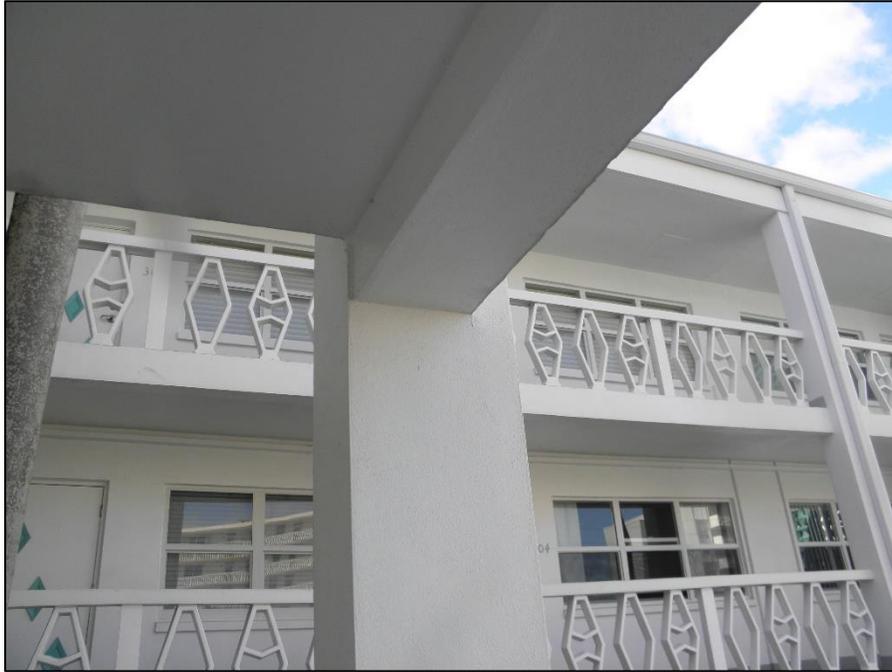
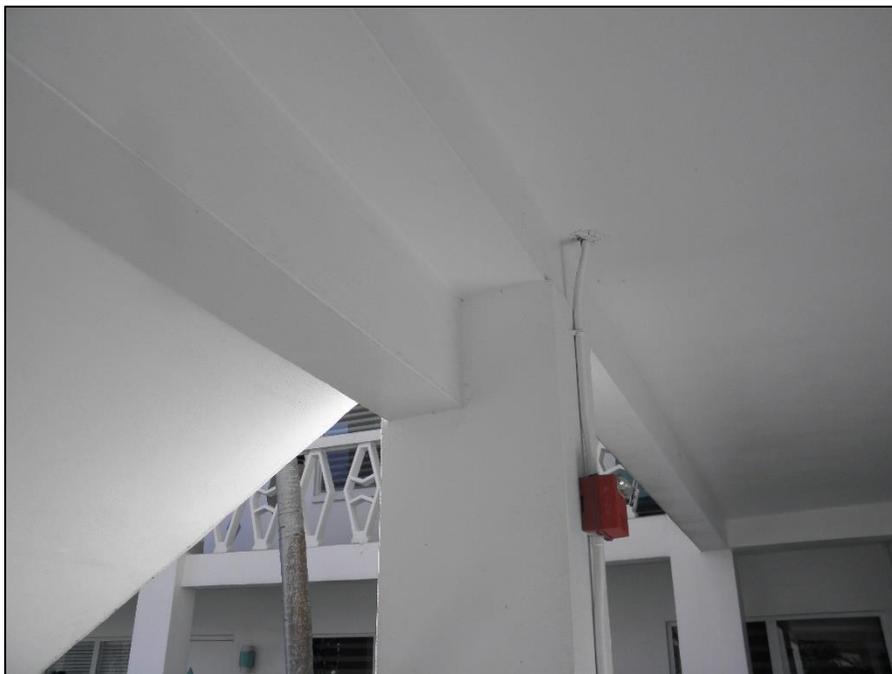
- In general, minimal cracking or stress was observed at exposed exterior concrete elements. Specifically, no cracking was observed at exposed beam-column joints (**Photographs 7 and 8**).

In general, no cracks were observed at exposed beam-column joints.

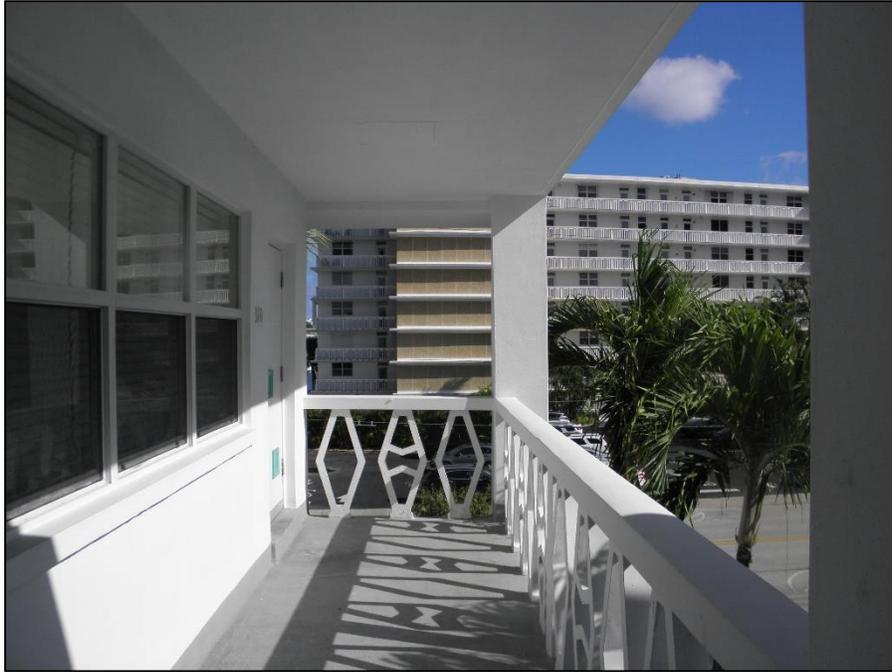
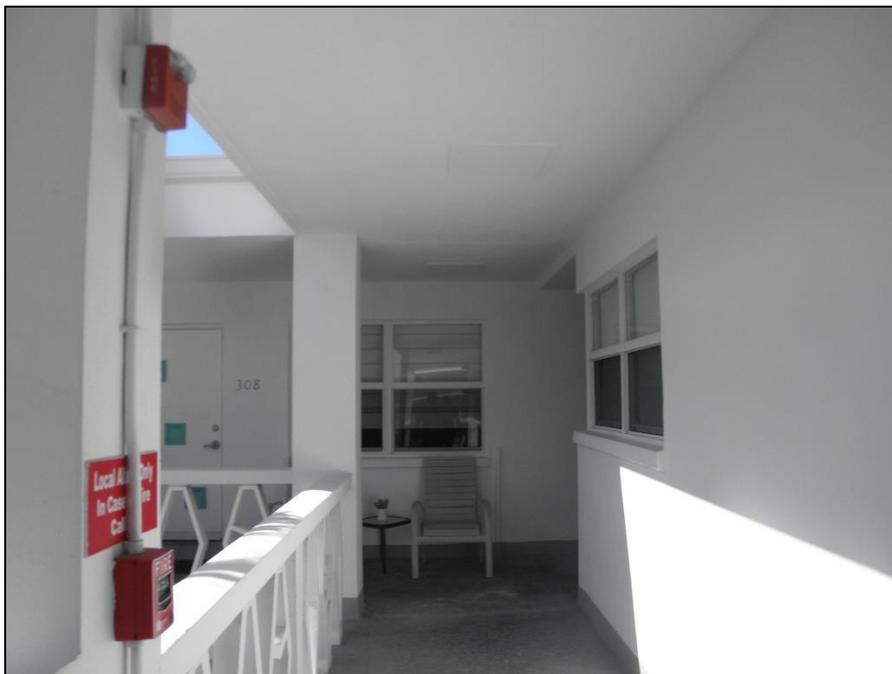
- In general, no cracks were observed in the stucco finish on the exterior walls of the building (**Photographs 9 and 10**).
- In general, no cracks were observed at the exterior cantilevered balconies (**Photographs 11 and 12**).

In general, no cracks were observed in the exterior wall finishes.

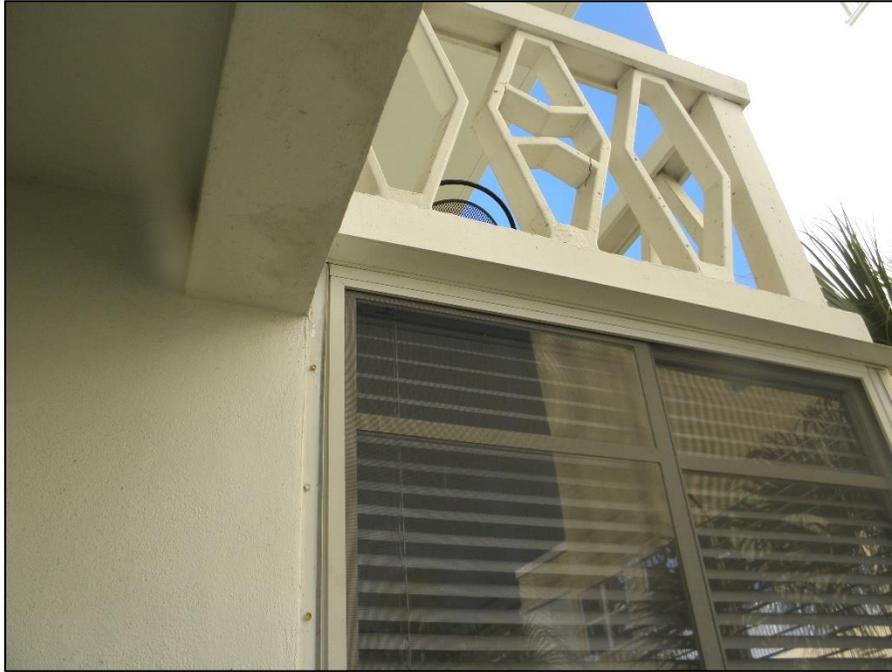
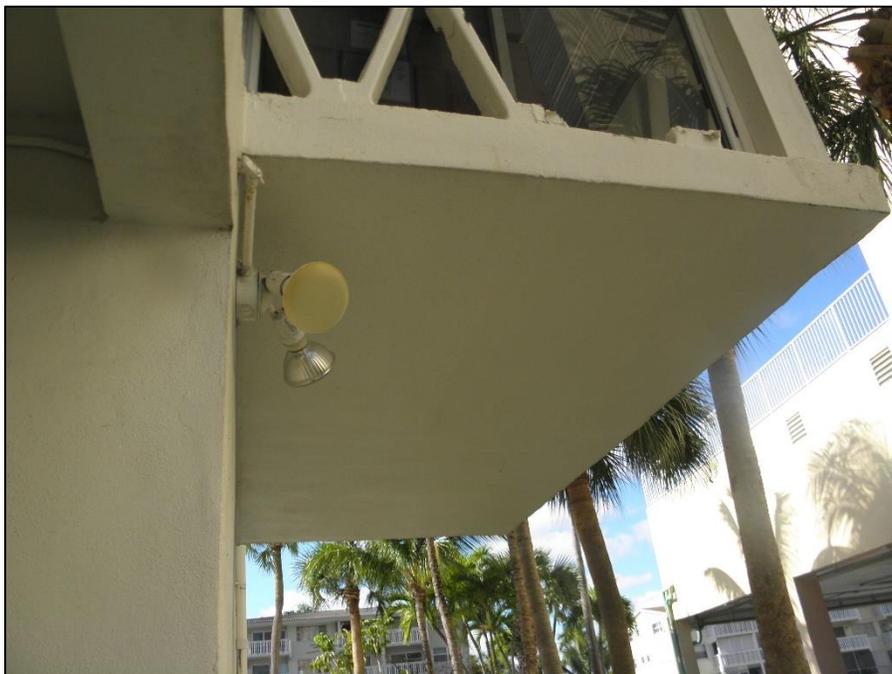
In general, no cracks were observed at the cantilevered balconies.

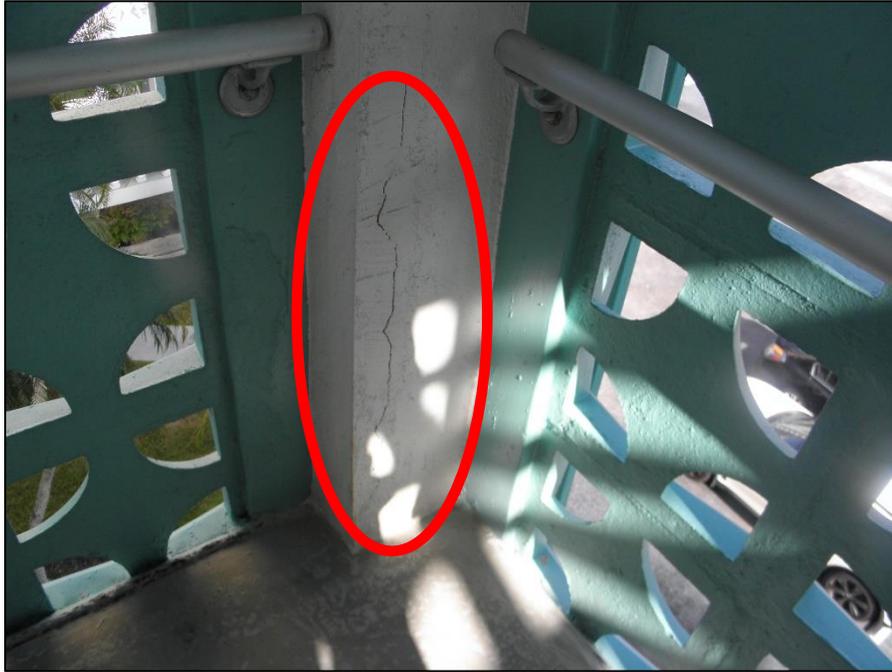
Photograph 13

- Several areas of localized cracking were observed at old concrete patches on concrete columns (**Photograph 13**).
- Several areas of peeling paint and rusted steel were observed in the decorative exterior walls of the stair/elevator tower (**Photograph 14**).

Minor cracks observed at an old patch on a concrete column.

- Year 1: Rework the cracked concrete patches on several columns and the minor concrete spalls on the soffit of the front and back exterior walkways.
- Year 1: Clean and repaint the peeling paint and corroded metal elements at the central stair/elevator tower exterior walls.

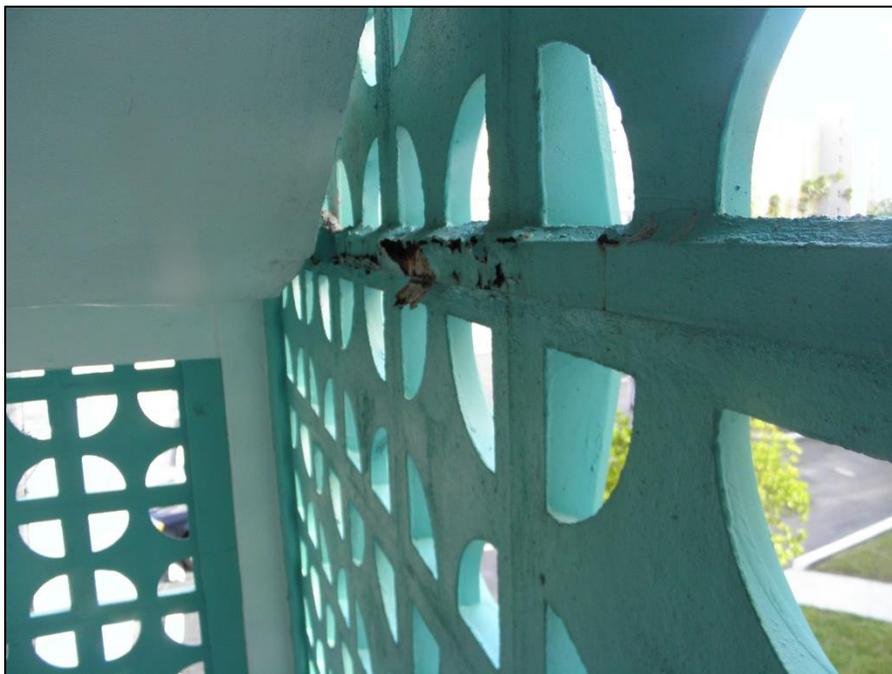
Photograph 14

Paint peeling at a stair tower beam.

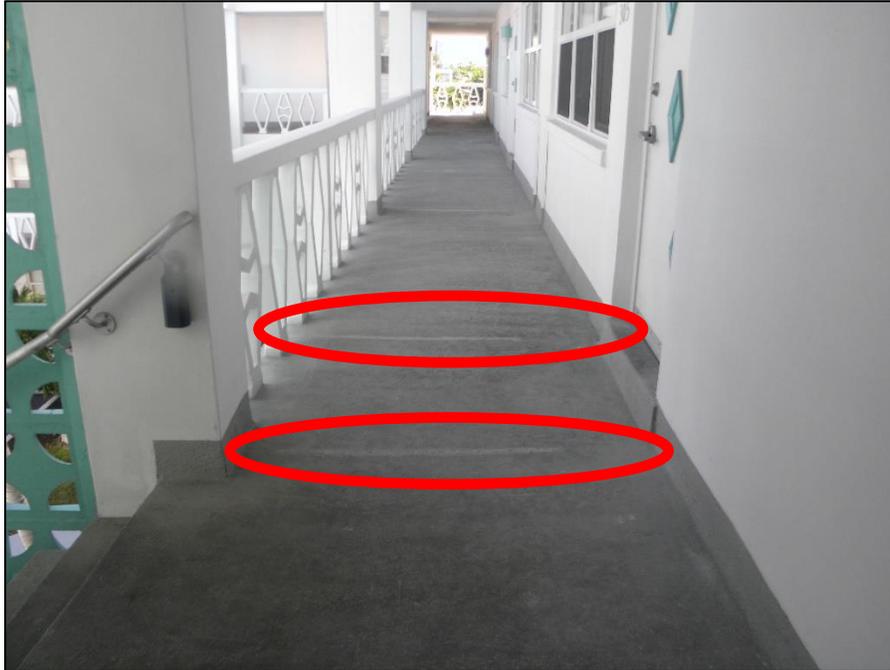
Photograph 15

- Transverse cracks were observed in the front and rear exterior walkways (**Photograph 15**). The hairline-width cracks were generally located at 10- to 15-foot intervals and went through the traffic coating applied to the long, linear, cantilevered walkway slabs.

Overview of typical transverse cracks in an exterior walkway.

Years 1 through 10: Seal cracks in traffic coating on the front and back exterior balconies.

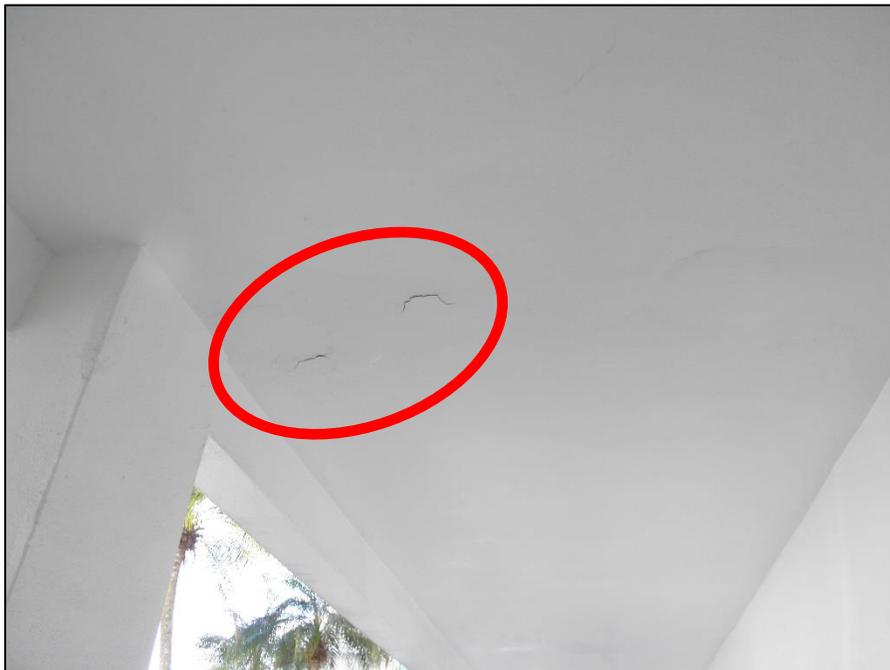
Photograph 16

- Isolated locations of minor spalling were observed in the concrete soffit under the transverse cracks in the front and rear cantilevered walkways (**Photograph 16**). Evidence of prior concrete patching was observed at these locations.

Overview of minor spalls in slab soffit under typical transverse cracks in an exterior walkway.

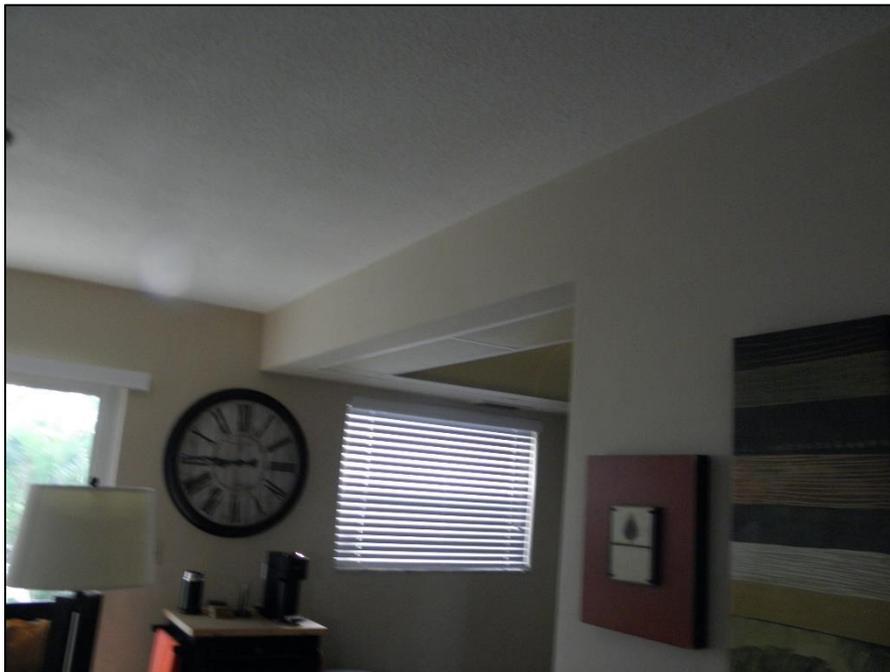
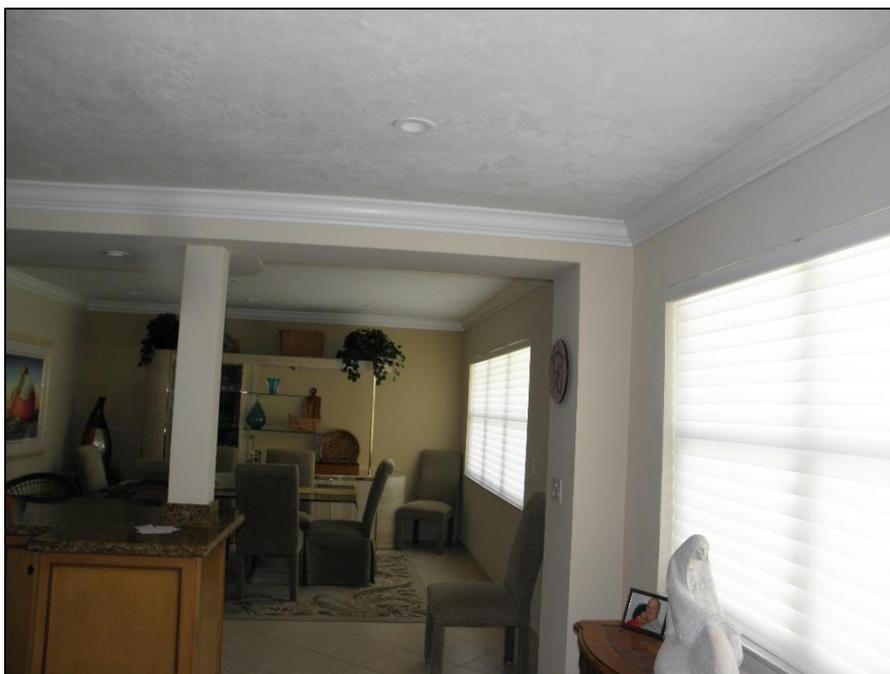
- The interiors of four random units were observed, units 202, 209, 303, and 307. No cracking or distress of significance was observed in the exposed concrete framing and wall finishes inside these units (**Photographs 17 and 18**).

No cracks were observed inside the units observed.

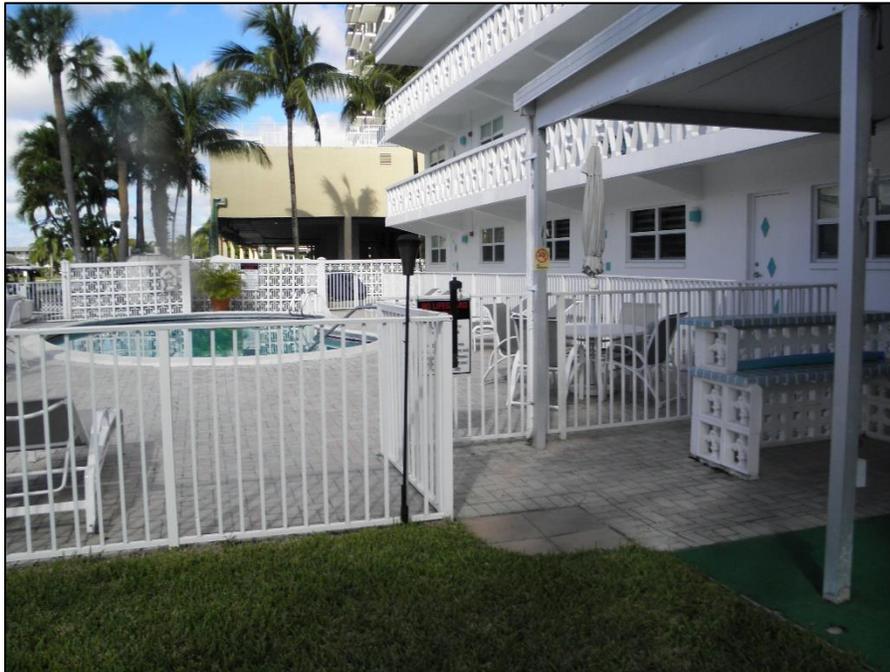
Photograph 19

- Minimal settlement and distress were observed at at-grade elements, such as slabs-on-grade, pool deck, and sidewalks near the building (**Photograph 19**).

Minimal settlement and distress were observed at at-grade slabs.

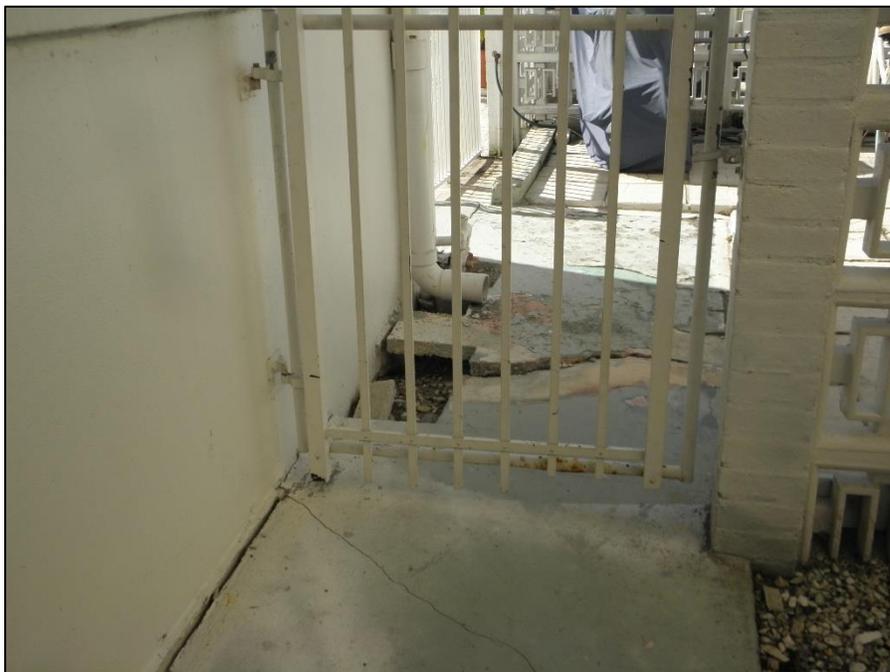
Photograph 20

- Isolated areas of settlement and distress were observed at several locations, generally near downspout discharge locations (**Photograph 20**).
- No settlement or lateral movement of significance was observed at the pool shell or the sea wall (**Photographs 21 and 22**).

Minor settlement and distress was observed at several isolated exterior locations.

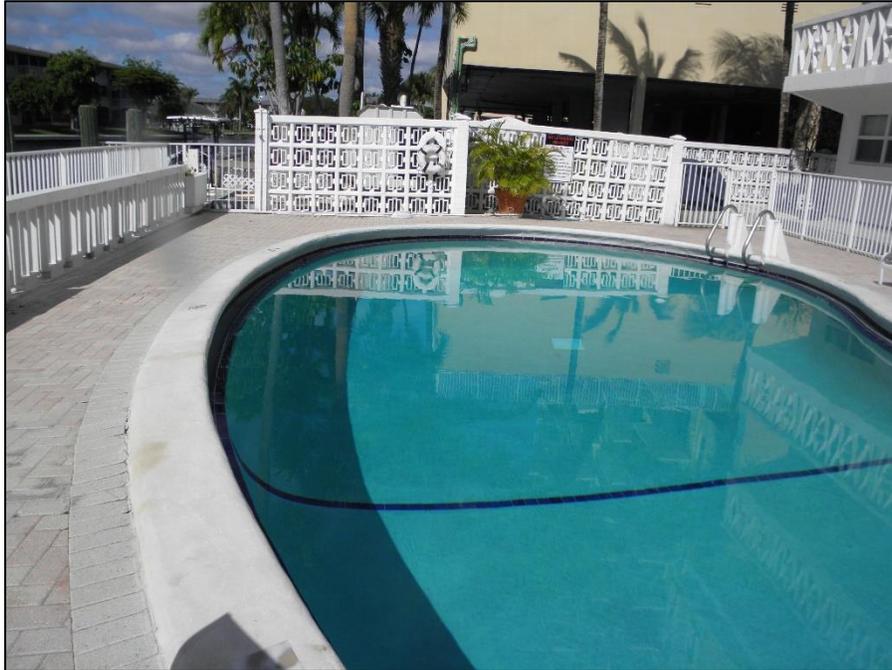
Photograph 21

No settlement or distress was observed in the pool shell.

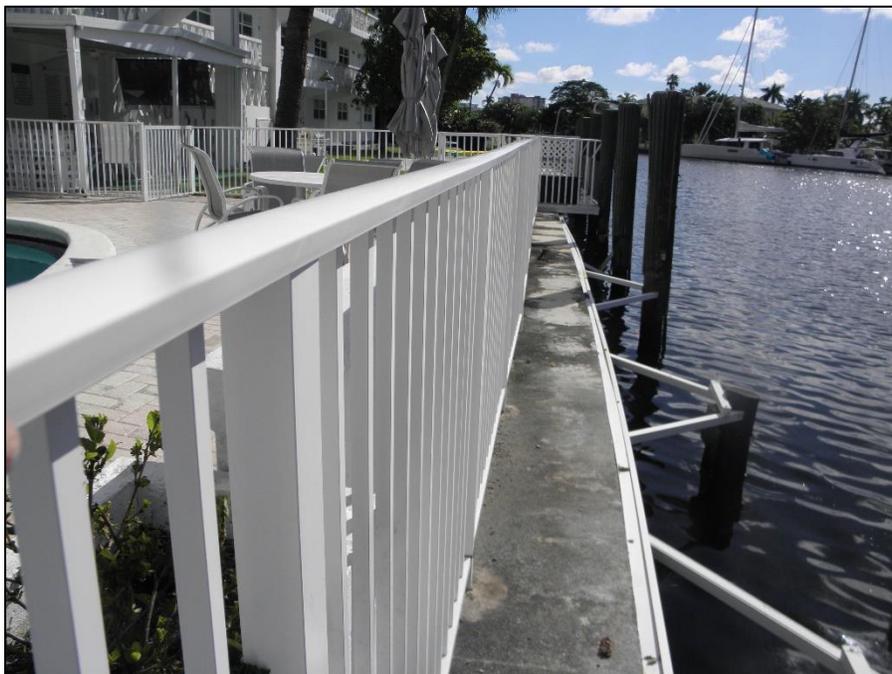
Photograph 22

No settlement or distress was observed at the seawall.

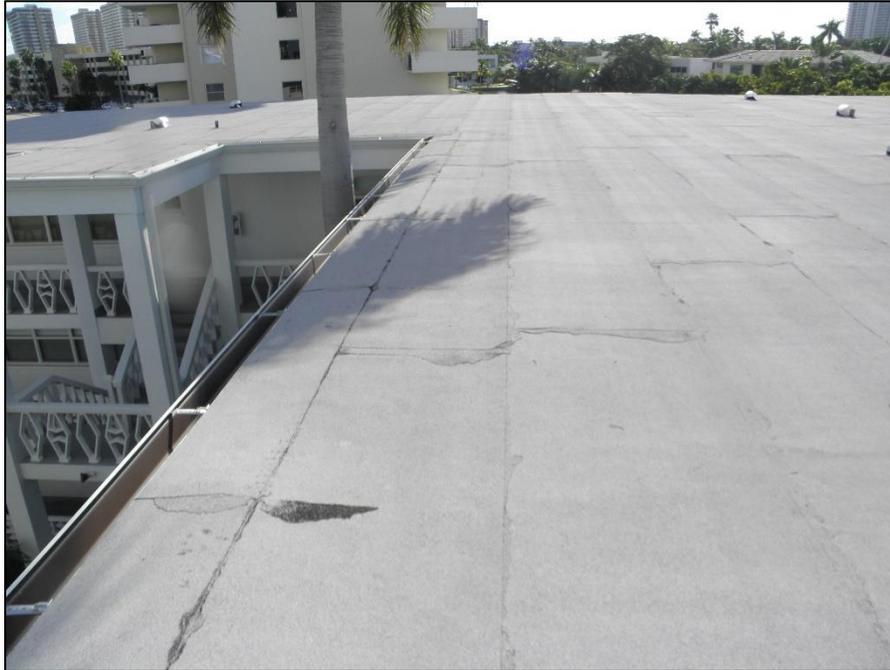
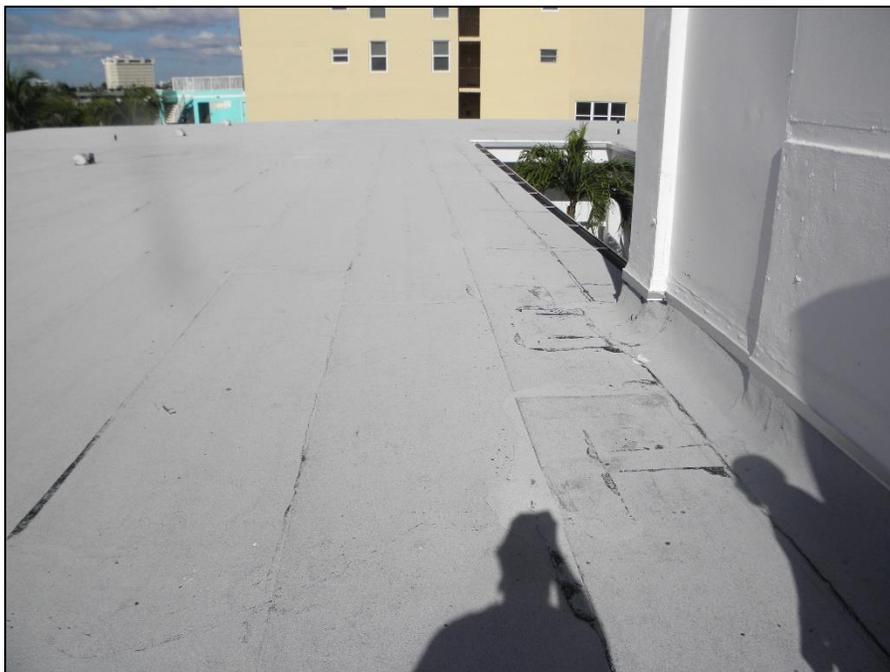
The roof of the buildings was a low-sloped, built-up roof (**Photographs 23 and 24**). Rolled roofing strips approximately 3 feet wide were observed oriented in the long direction of the building. Stormwater was conveyed to the exterior of the roof into an exterior gutter system with interior roof drains located near the edges of the roof (**Photographs 25 and 26**).

The roof was in good condition.

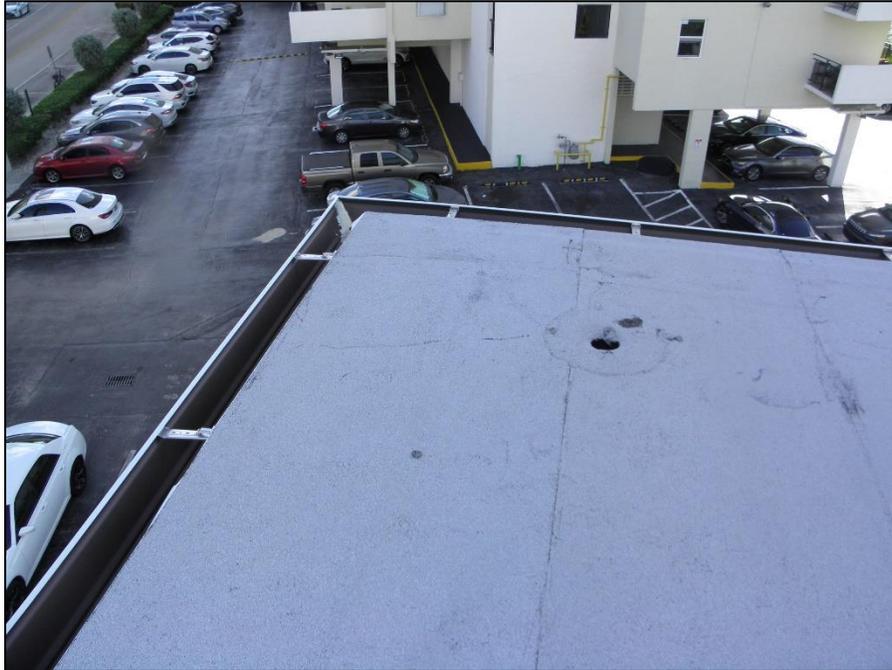
Photograph 25

Typical view exterior gutter with adjacent interior roof drain.

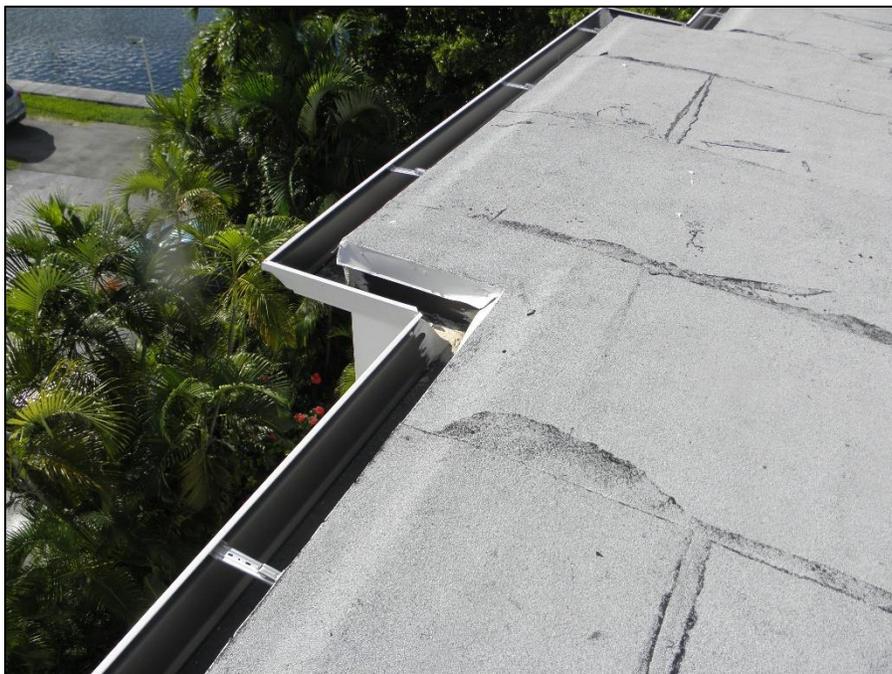
Photograph 26

Typical view exterior gutter.

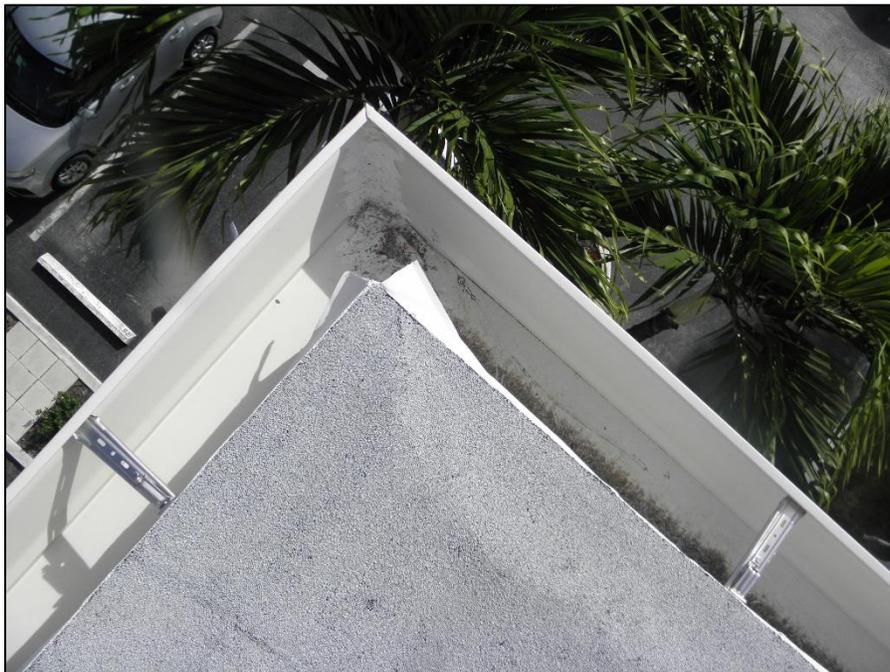
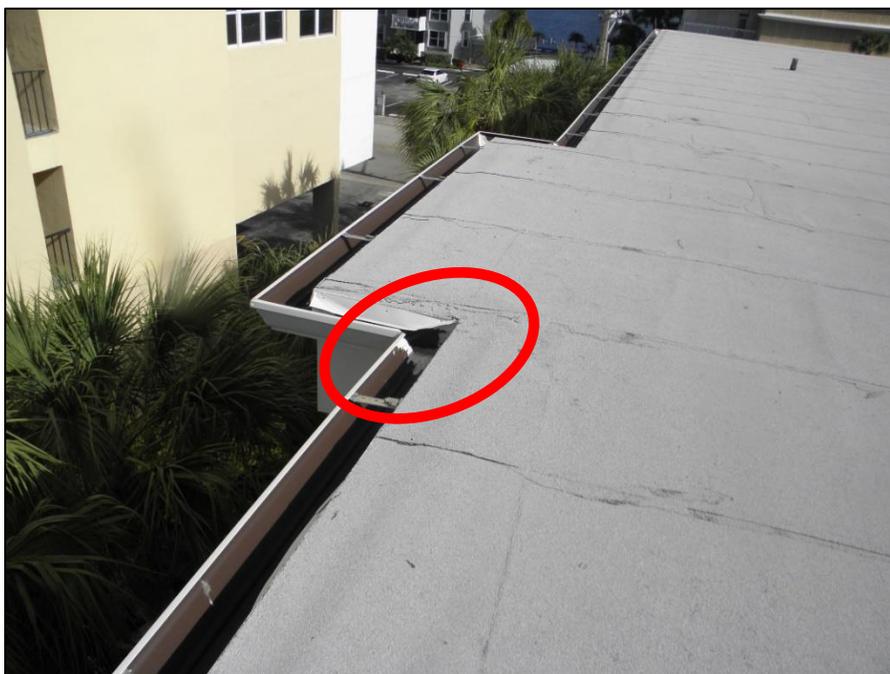
- The metal roof edge flashing at several gutter corners was bent and was not laying flush with the sidewall of the gutter (**Photographs 27 and 28**).

The roof edge flashing was bent at gutter corners.

- Year 1: Repair the bent roof flashing at gutter corners.
