STRUCTURAL SAFETY INSPECTION REPORT FORM

Inspection Firm or Individual Name: John H. Stewart, P.E. of Rimkus Consulting Group

1. DESCRIPTION OF STRUCTURE		
a. Name on Title:	Yorkdale's Carrallton Isles Association, Inc.	
b. Street Address:	419 Golden Isles Drive, Hallandale Beach, FL	
c. Legal Description:	Yorkdale's Carrallton Isles perCDO Bk/Pg 3930/403	
d. Owner's Name:	Yorkdale's Carrallton Isles Association, Inc.	
e. Owner's Mailing Address:	419 Golden Isles Drive, Hallandale Beach, FL	
f. Email Address:	henrycarrhoops@aol.com	Contact Number: 647-244-0922
g. Folio Number of Property on which building is located:	1226-06-0120	
h. Building Code Occupancy Classification:	Residential, R-2	
i. Present Use:	Condominiums	
j. General Description:	Multi-story building (photos 1 to 3)	Type of Construction: Concrete framing with CMU infill
k. Square Footage:	30,366	Number of Stories: 3
l. Is this a threshold building (per F.S. 553.71):	<input type="checkbox"/> Yes	<input checked="" type="checkbox"/> No

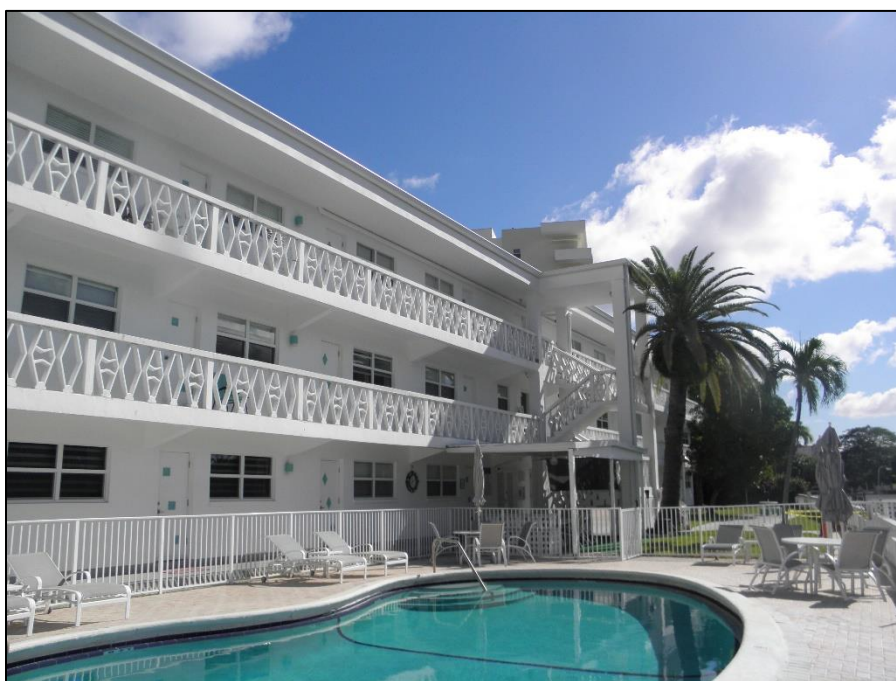
Photograph 2
Back (west) elevation of building.

Exterior walkways & stairs, see photographs 5 and 6. In-ground pool and seawall behind building, see photographs 2 and 4

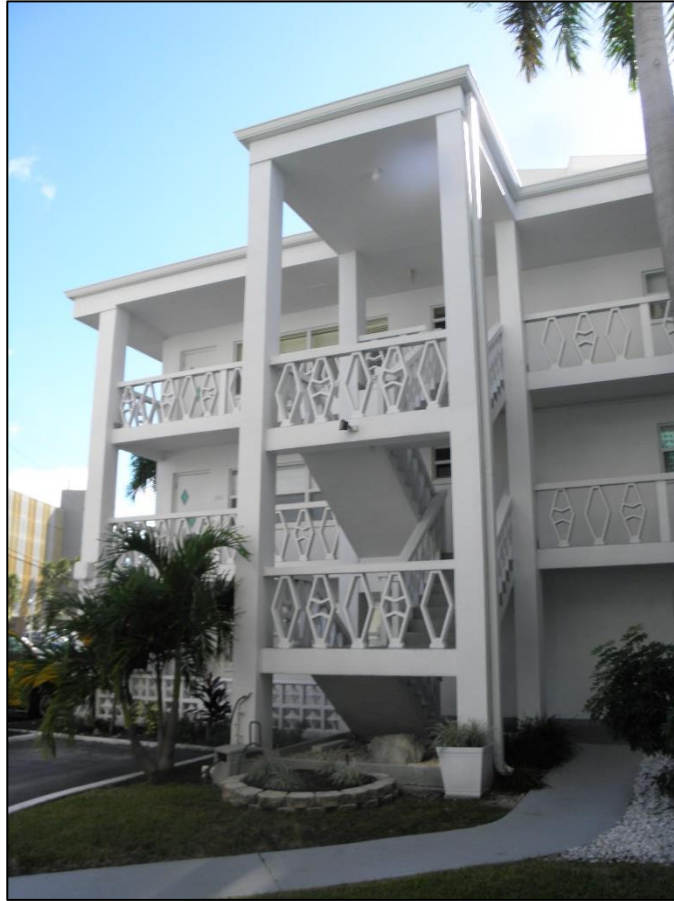
Photograph 5

Typical view of stair tower at north and south wings.

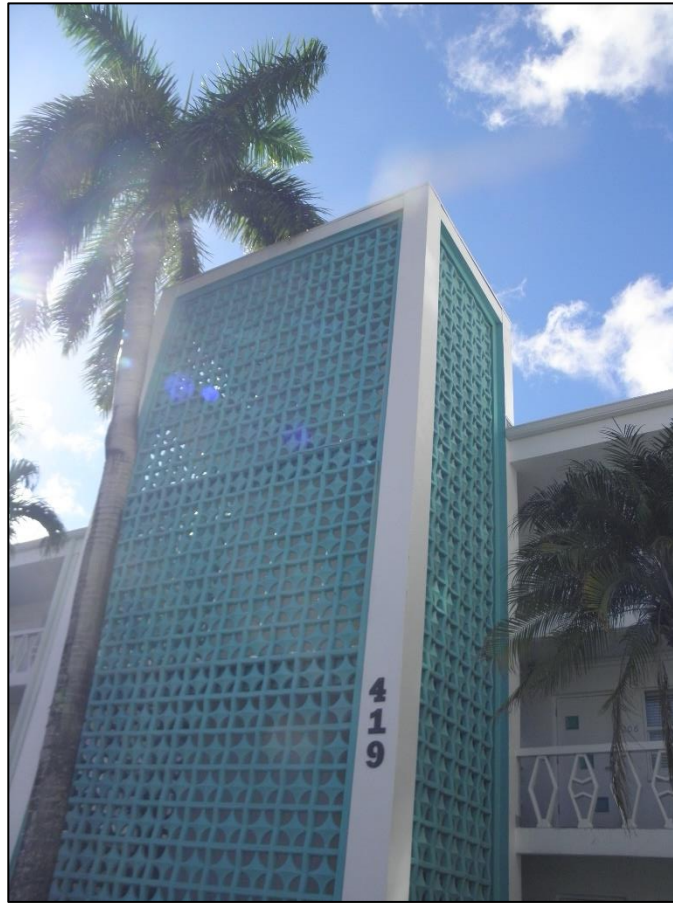
Photograph 6

View of central stair/elevator tower on east side of building.

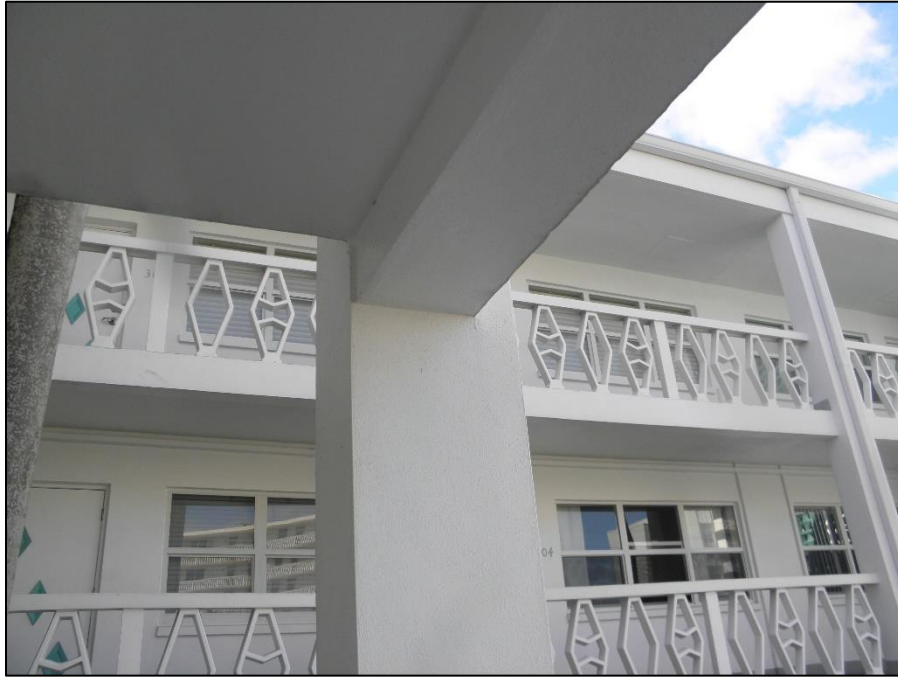
Photograph 7

Reinforced concrete stair towers located at center front of building and at each end of building and center back of building. All stair towers in good condition, see photographs 7 and 8

Concrete guardrails in good condition, see photographs 7 and 9.

In general, no cracks were observed at exposed beam-column joints.

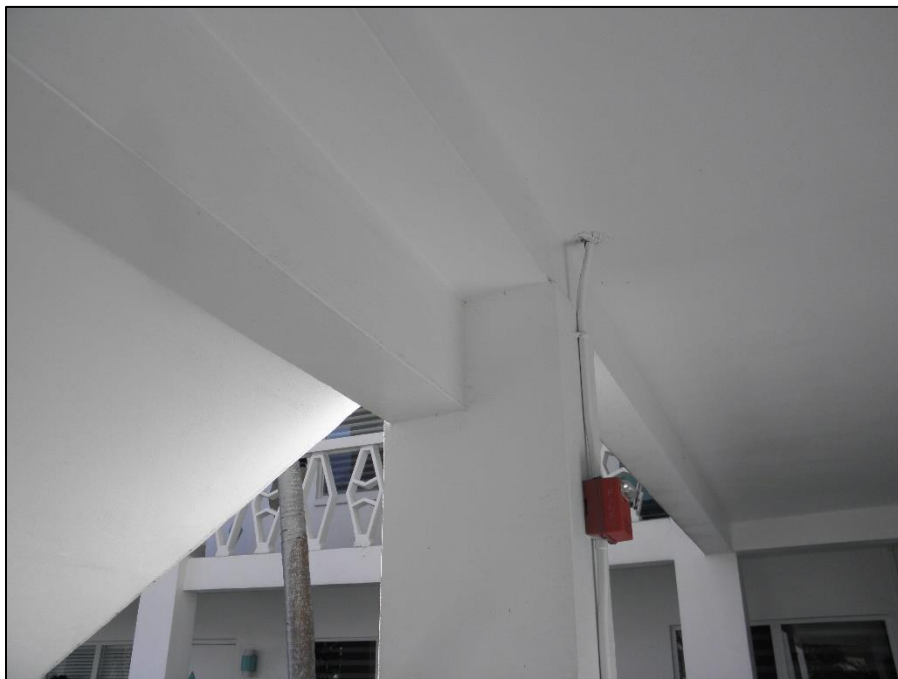
Photograph 8

In general, no cracks were observed at exposed beam-column joints.

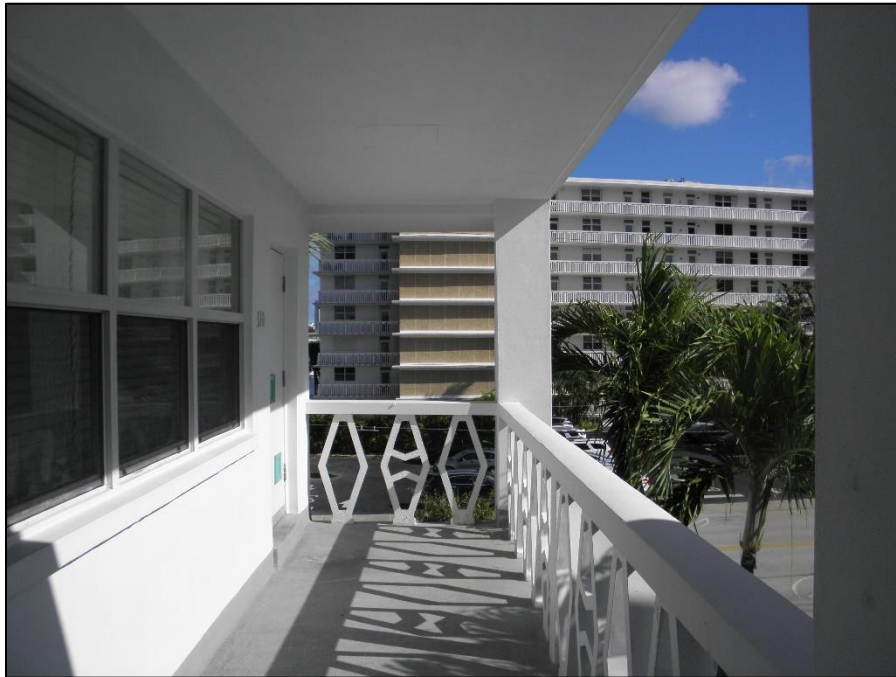
Photograph 9

4a. Explain: Exterior wall finishes in good condition, see photographs 9 and 10.

In general, no cracks were observed in the exterior wall finishes.

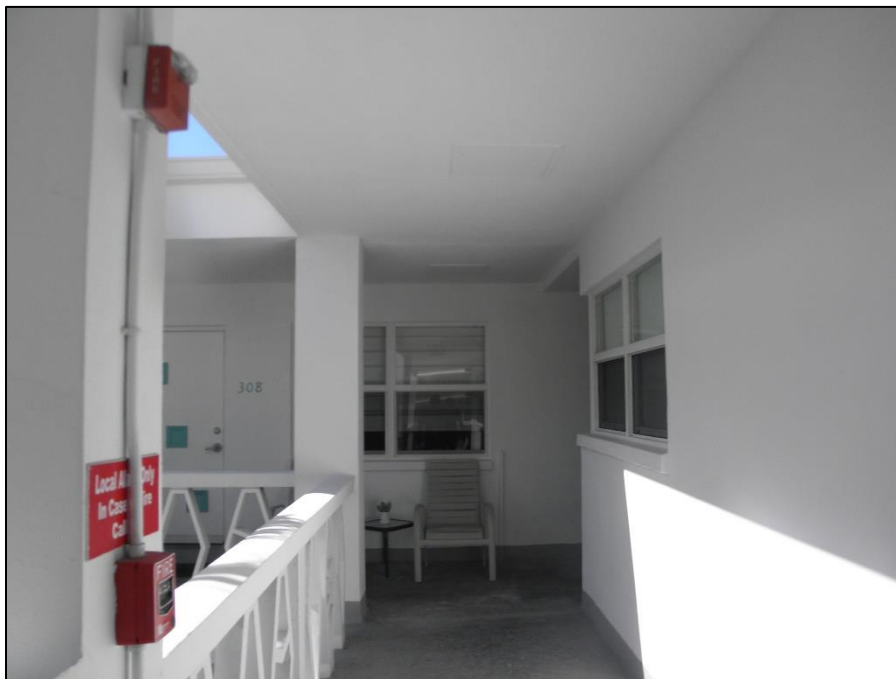
Photograph 10

In general, no cracks were observed in the exterior wall finishes.

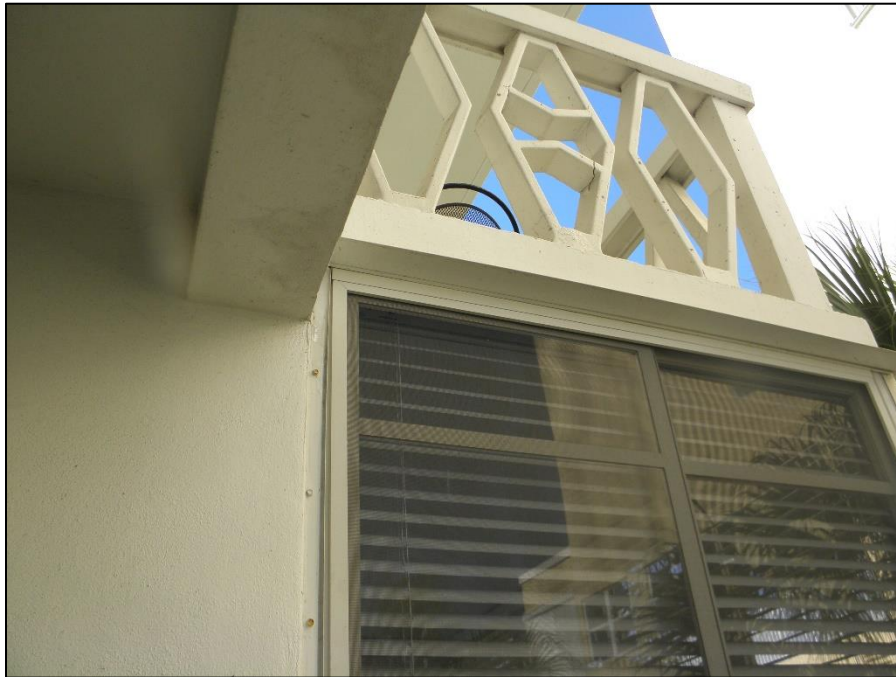
Photograph 11

Cantilevered reinforced concrete balcony slab at exterior of some of the units in good condition, see photographs 11 and 12.

In general, no cracks were observed at the cantilevered balconies.

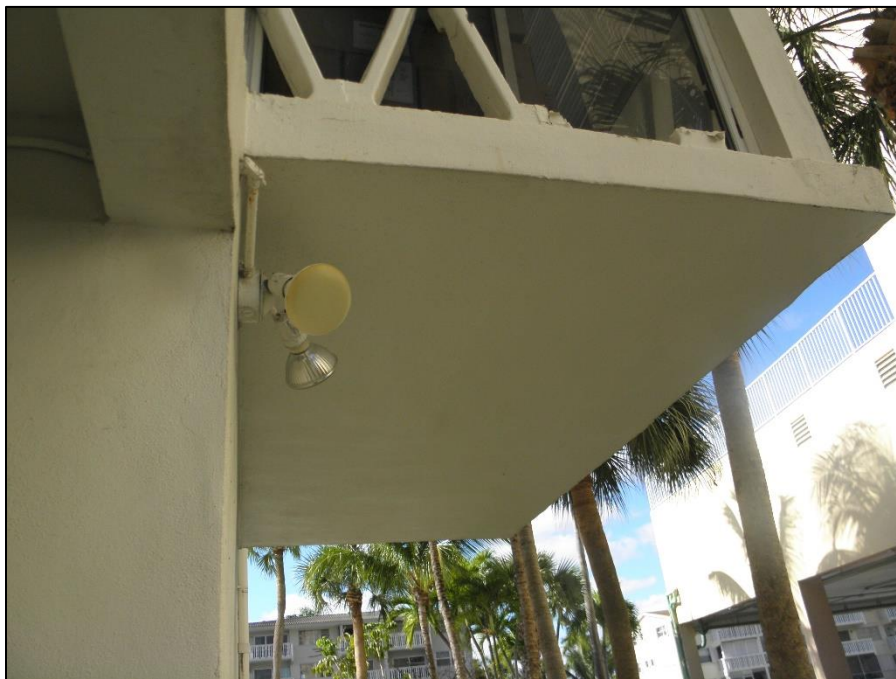
Photograph 12

In general, no cracks were observed at the cantilevered balconies.

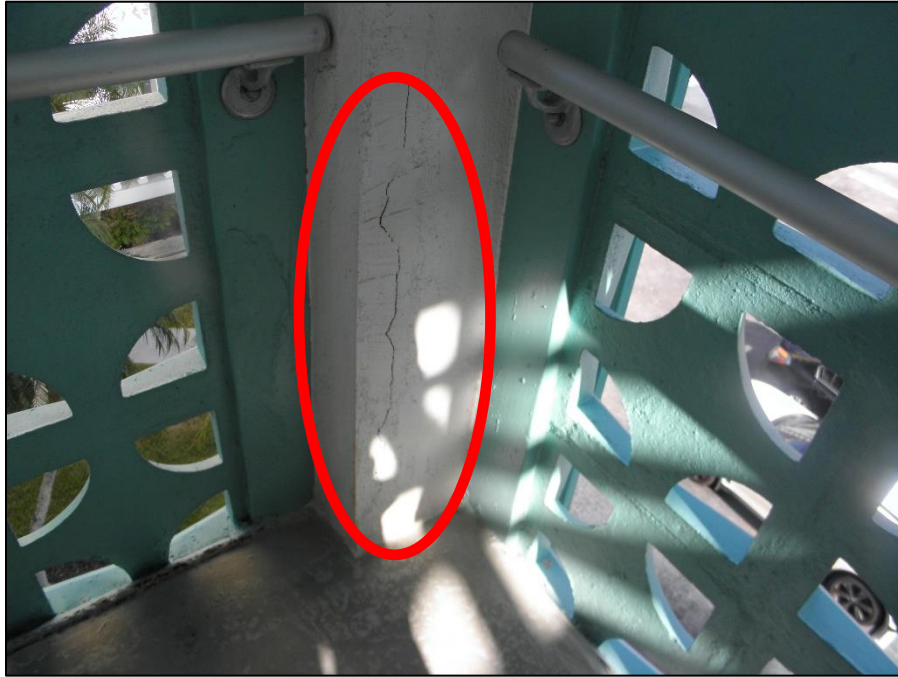
Photograph 13

b. Portion Showing Distress (Note: Beams, Columns, Structural Walls, Floor, Roofs, Other):
Hairline vertical cracks observed on one concrete column in the front stairwell, see photograph 13.
Minor spalls noted on soffit of front walkway slab, see photograph 16. Owner reports he has repaired these items after my inspection.

One concrete column in the front stair tower had minor vertical cracks, see previous comments and photograph. Owner reports he has repaired these items after my inspection.

Minor cracks observed at an old patch on a concrete column.

Item No.	Recommendation	EUL	Age	RUL	Quantity	Unit	Unit Cost	Immediate (0 - 6 Months)	Year 1	Year 2	Year 3	Year 4	Year 5	Year 6	Year 7	Year 8	Year 9	Year 10	10-Year Totals	Other
1	Repair the cracked concrete patches on several columns and the minor concrete spalls on the soffit of the front and back exterior walkways.	100	60	40	10	EA	\$500		\$5,000											
2	Clean and repaint the peeling paint and corroded metal elements at the central stair/elevator tower exterior walls.	8	Unknown	0	1,680	SF	\$3.00		\$5,040											
Subtotal								\$0	\$10,040	\$0	\$0	\$0	\$0	\$0	\$0	\$0	\$0	\$0	\$0

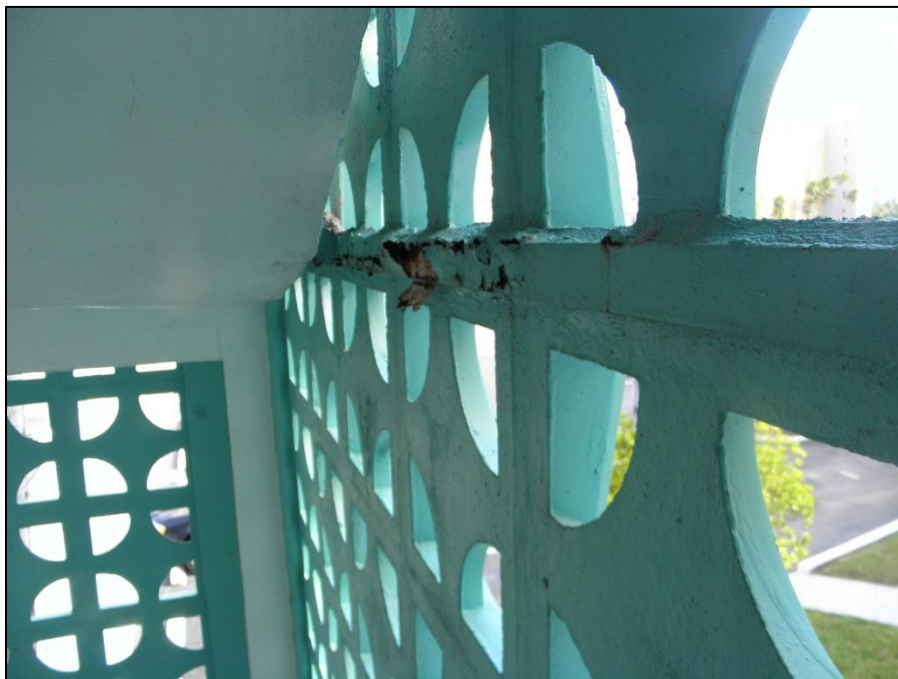
Photograph 14

c. Surface Conditions – Describe general conditions of finishes, noting cracking, spalling, peeling, signs of moisture penetration and strains:
Hairline horizontal cracks in floor coating on front walkway slab, see photograph 15.
Minor paint peeling and corrosion noted on decorative wall surface of front stair tower, see photograph 14.
Owner reports he has repaired these items after my inspection.

Paint peeling at a stair tower beam.

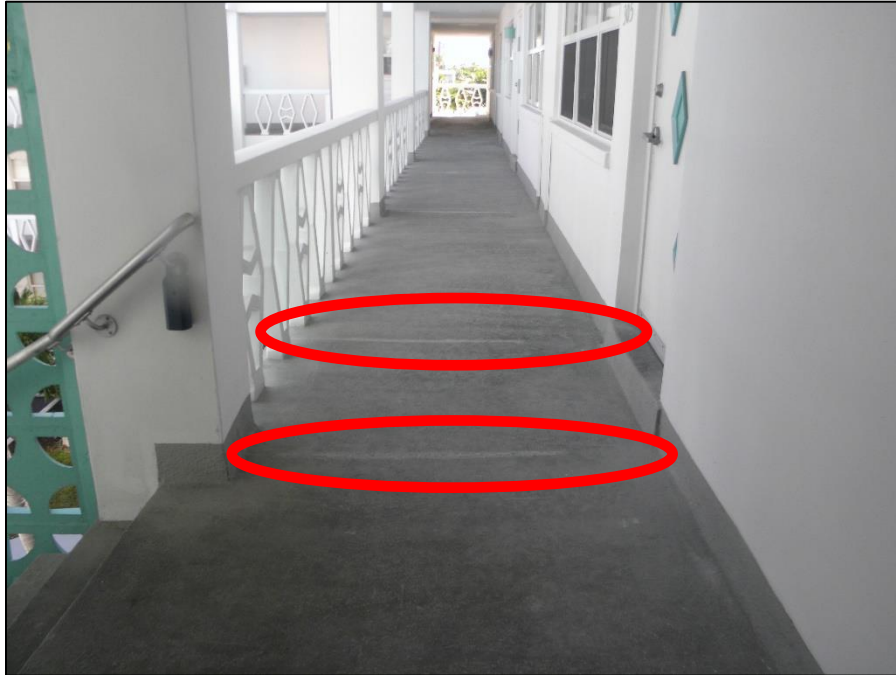
Photograph 15

Overview of typical transverse cracks in an exterior walkway.

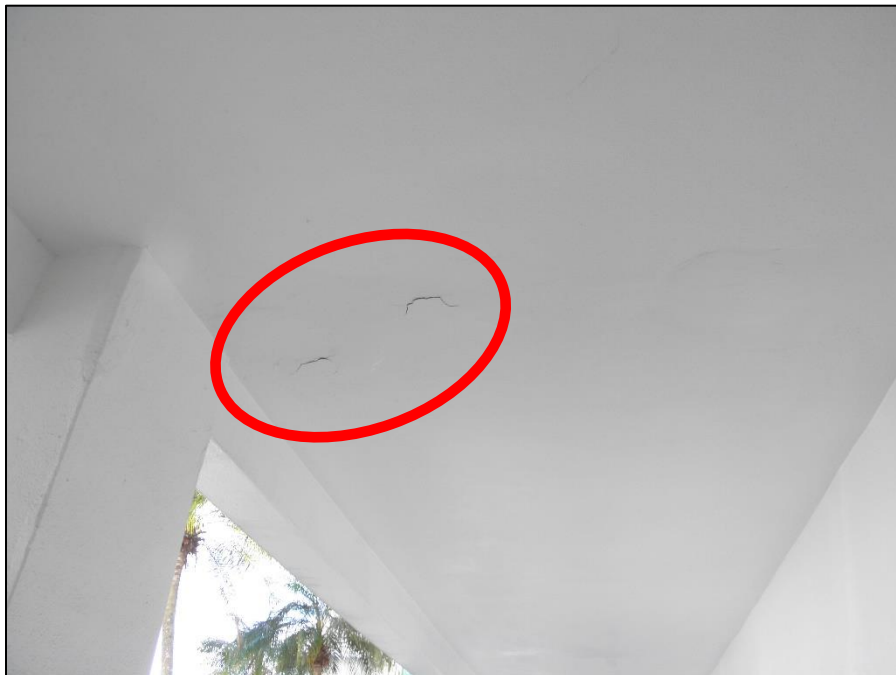
Photograph 16

Overview of minor spalls in slab soffit under typical transverse cracks in an exterior walkway.

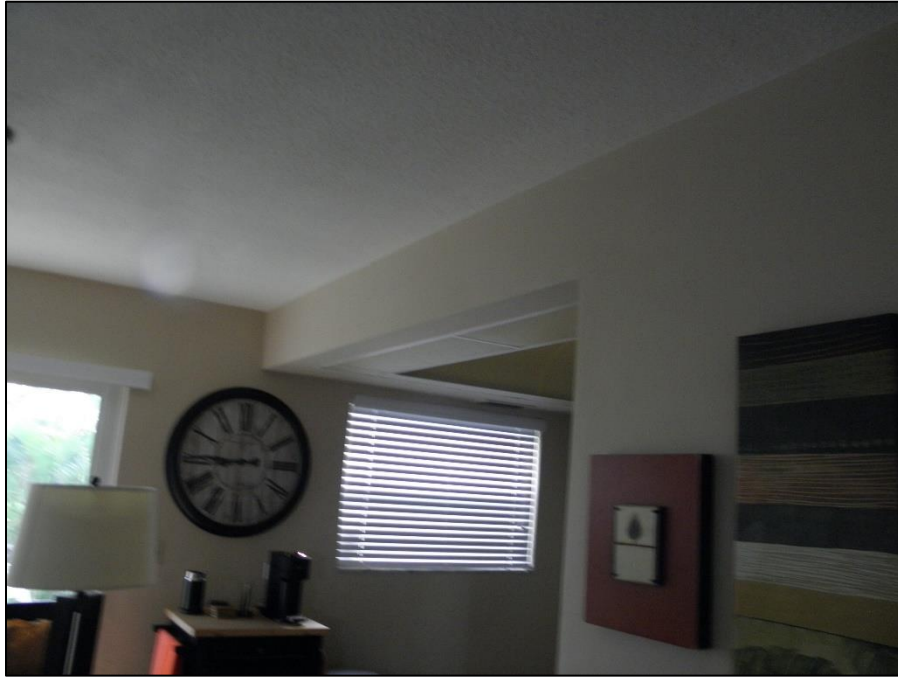
Photograph 17

Steel bar joist with concrete floor slab system, no cracks or deflections issues noted in 4 representative units inspected, see photographs 17 and 18.

No cracks were observed inside the units observed.

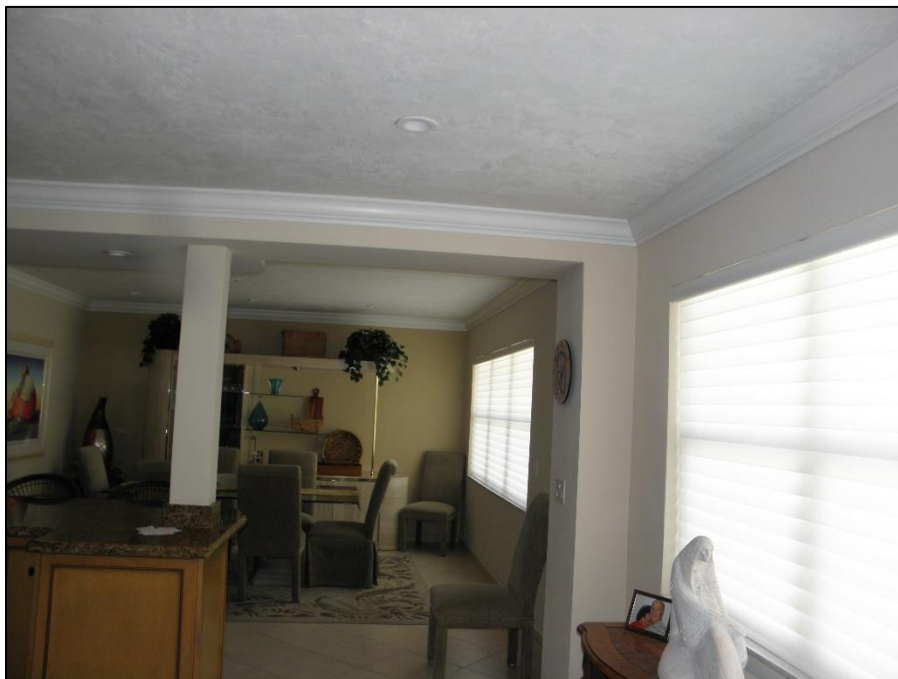
Photograph 18

No cracks were observed inside the units observed.

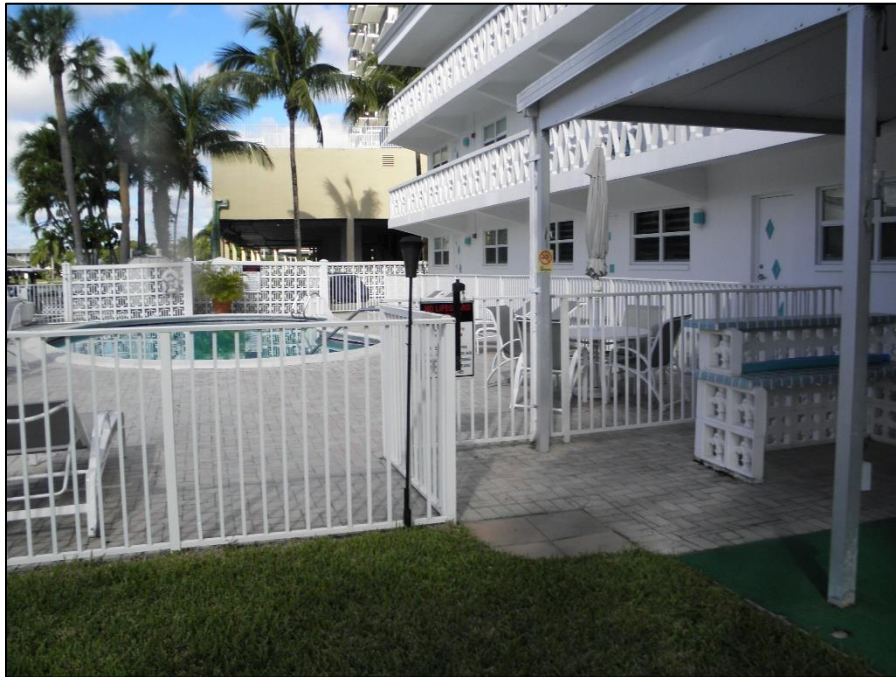
Photograph 19

d. Describe any cracks or separation in the walls, column or beams that signal differential settlement:
None observed in the building structure. Minor settlement of non-structural slab-on-grade adjacent to building noted at several locations, see photographs 19 and 20.

Minimal settlement and distress were observed at at-grade slabs.

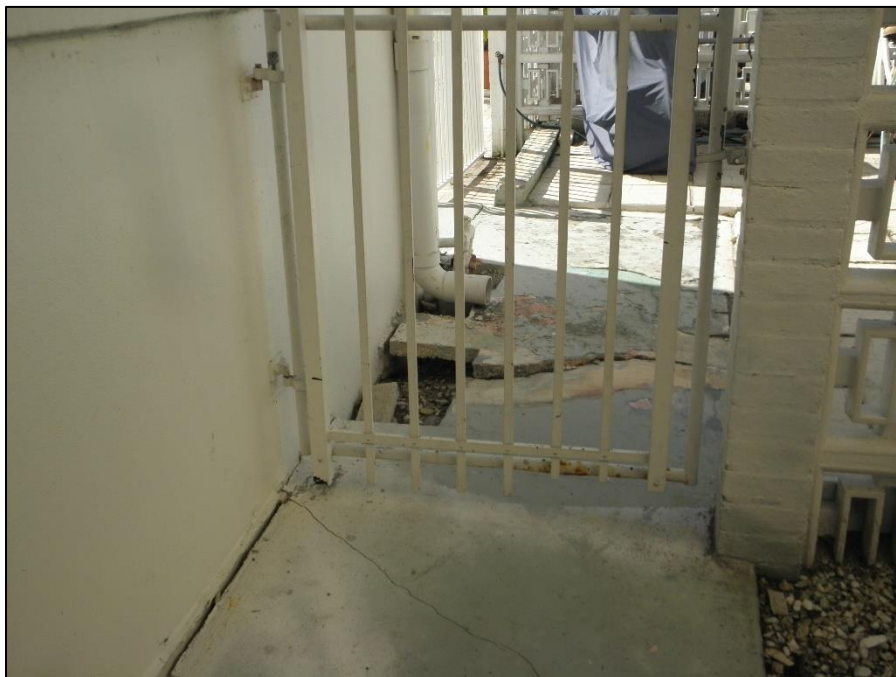
Photograph 20

Minor settlement and distress was observed at several isolated exterior locations.

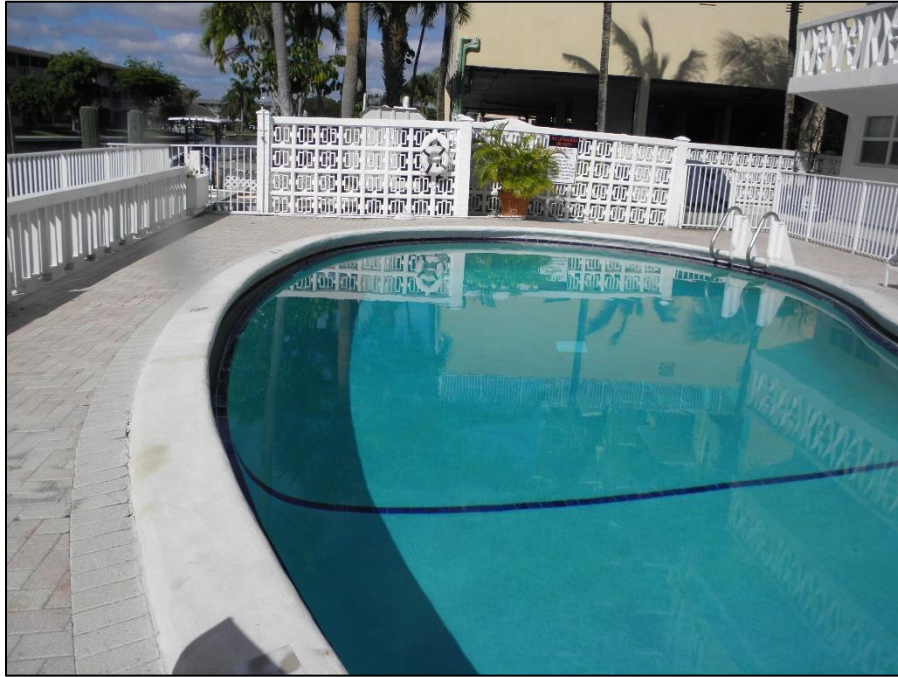
Photograph 21

Seawall behind the building is in good condition with no significant movements or deterioration noted, see photograph 22. In-ground pool located behind building is in good condition. No significant movements or deterioration noted in the pool shell, see photograph 21.

No settlement or distress was observed in the pool shell.

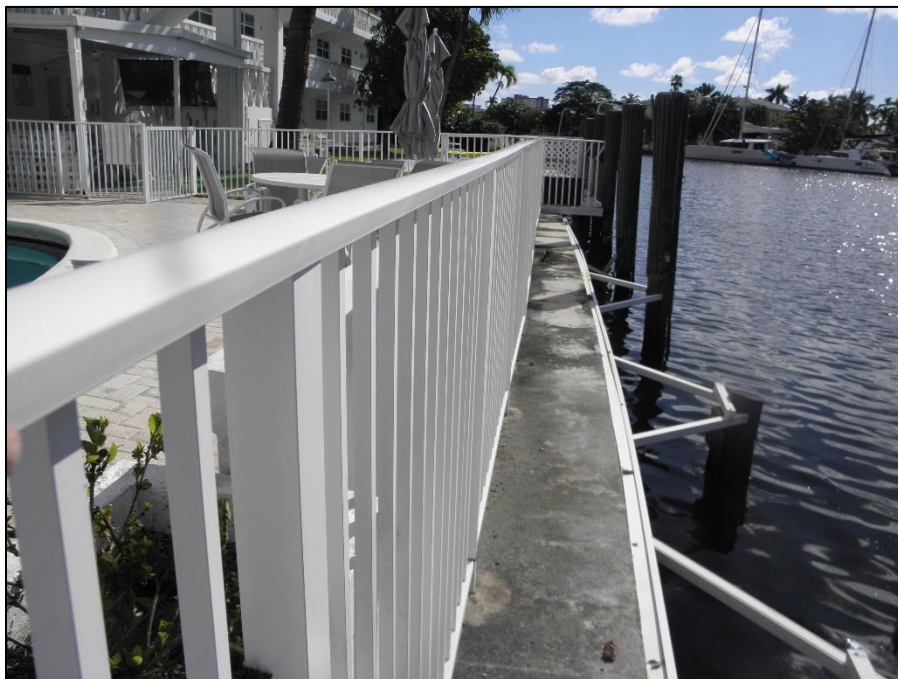
Photograph 22

No settlement or distress was observed at the seawall.

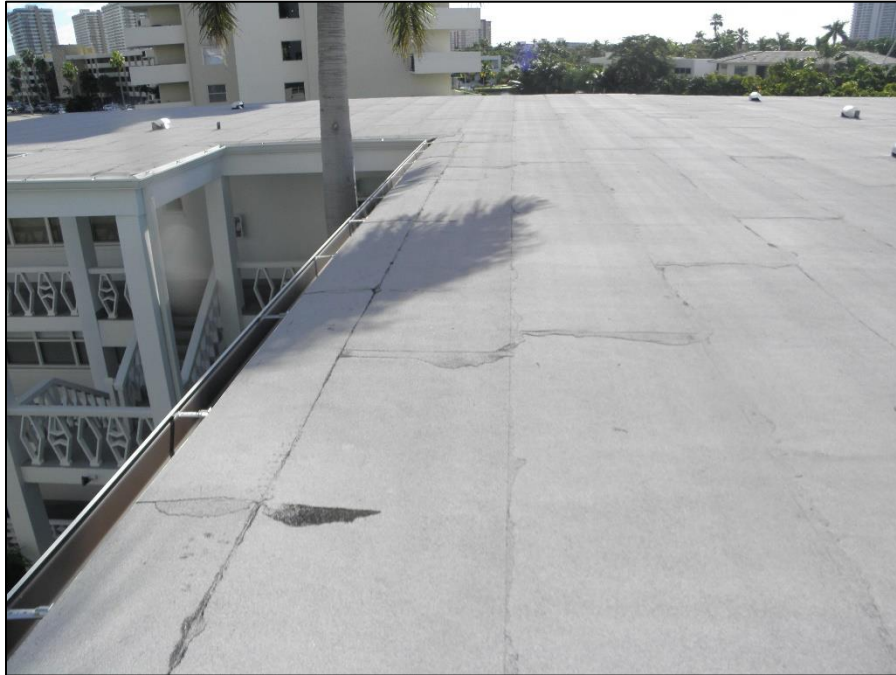
Photograph 23

a. **Roof:** Built-up roof membrane with granulated surface, see photograph 23 and 24

The roof was in good condition.

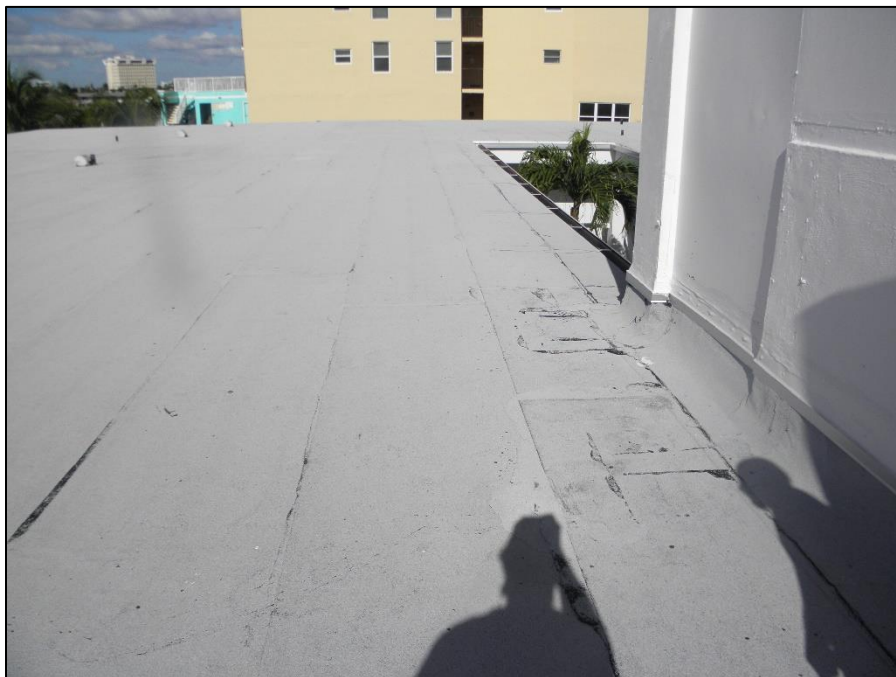
Photograph 24

The roof was in good condition.

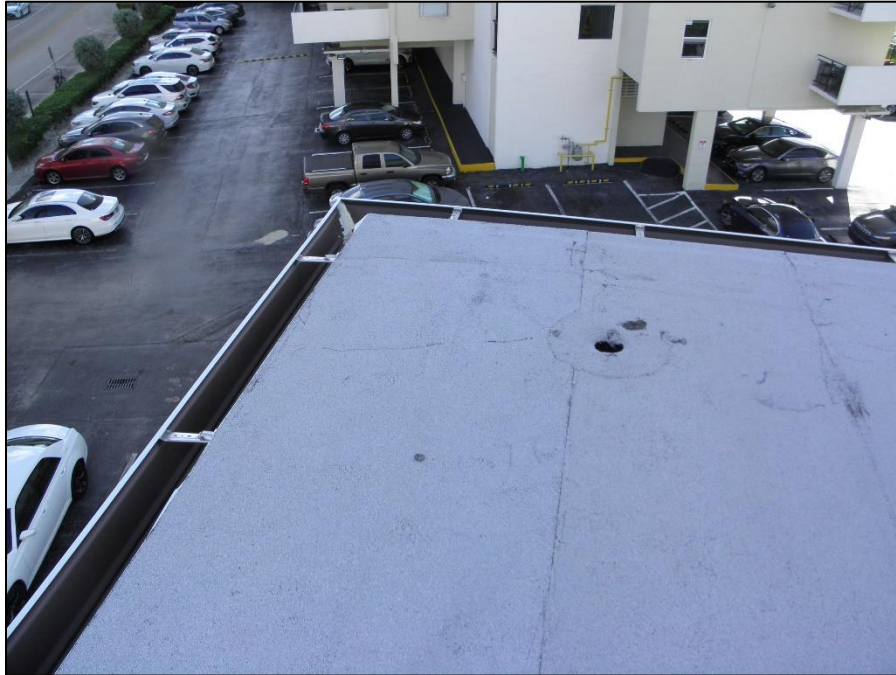
Photograph 25

3. Note types of drains, scuppers, and condition:
Gutters around perimeter of roof in good condition, see photographs 25 and 26

Typical view exterior gutter with adjacent interior roof drain.

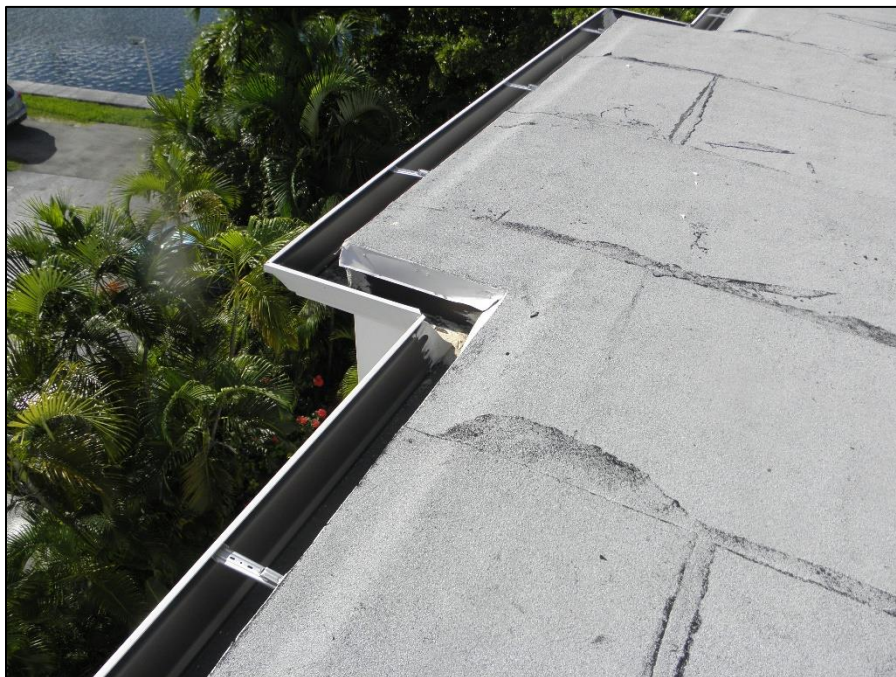
Photograph 26

Typical view exterior gutter.

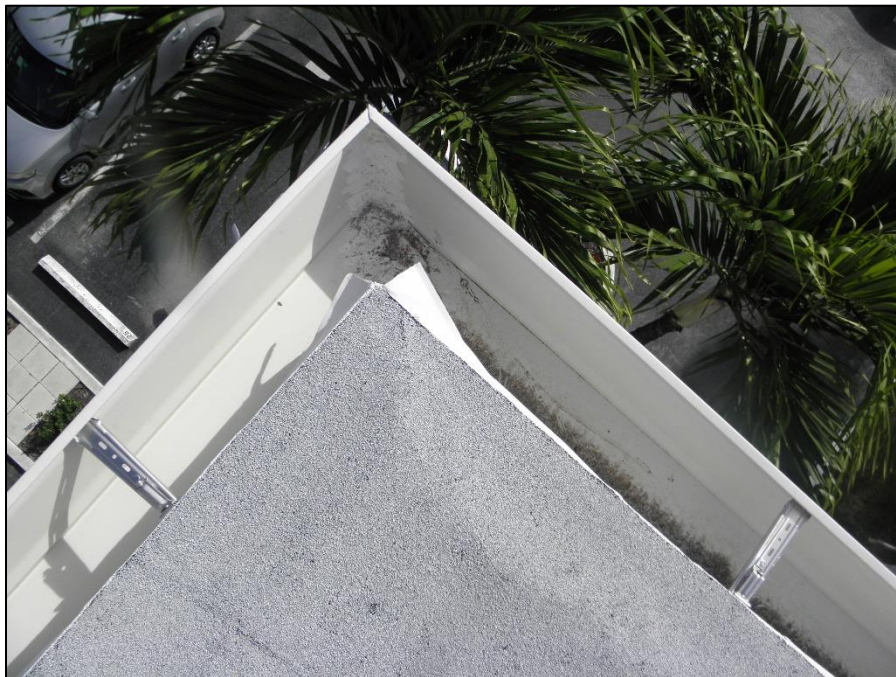
Photograph 27

Good condition, several areas with minor bent roof flashing, see photographs 27 and 28.
Owner reports he has repaired these items after my inspection.

The roof edge flashing was bent at gutter corners.

Item No.	Recommendation	EUL	Age	RUL	Quantity	Unit	Unit Cost	Immediate (0 - 6 Months)	Year 1	Year 2	Year 3	Year 4	Year 5	Year 6	Year 7	Year 8	Year 9	Year 10	10-Year Totals	Other	
3	Repair the bent roof flashing at gutter corners.	20	Unkown	NA	28	EA	\$50		\$1,400										\$1,400		
Subtotal								\$0	\$1,400	\$0	\$0	\$0	\$0	\$0	\$0	\$0	\$0	\$0	\$0	\$1,400	
TOTALS:								\$0	\$11,440	\$0	\$0	\$0	\$0	\$0	\$0	\$0	\$0	\$0	\$0	\$1,400	
OVERALL TOTAL (IMMEDIATE AND 10-YEAR):																				\$11,440

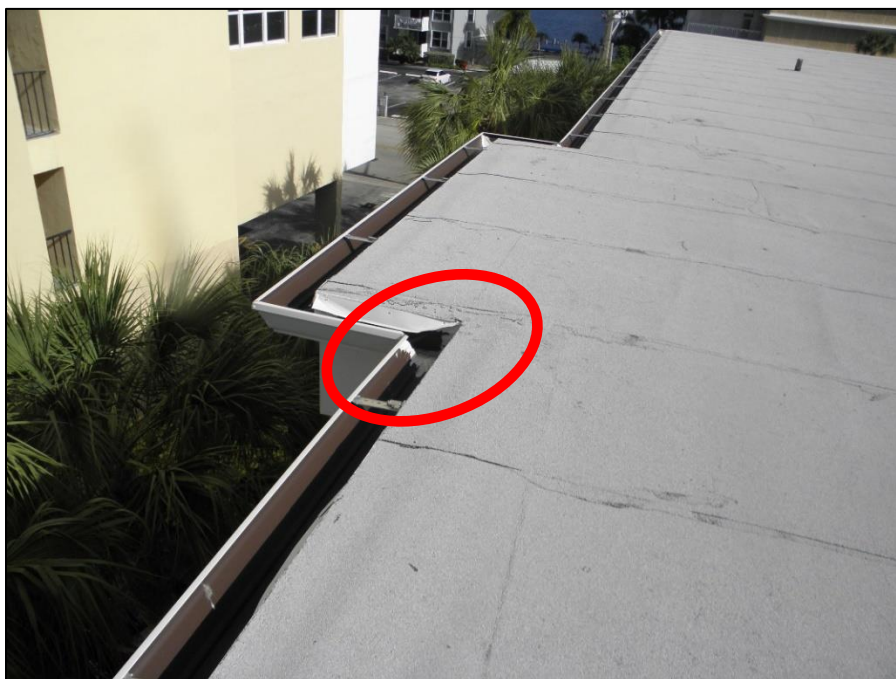
Photograph 28

The roof edge flashing was bent at gutter corners.
